**Exponent Report on PG&E Caribou-  
Palermo Asset Condition Investigation**

**November 1, 2019**

## **PG&E Caribou-Palermo Asset Condition Investigation**

Exponent  
149 Commonwealth Drive  
Menlo Park, CA 94025

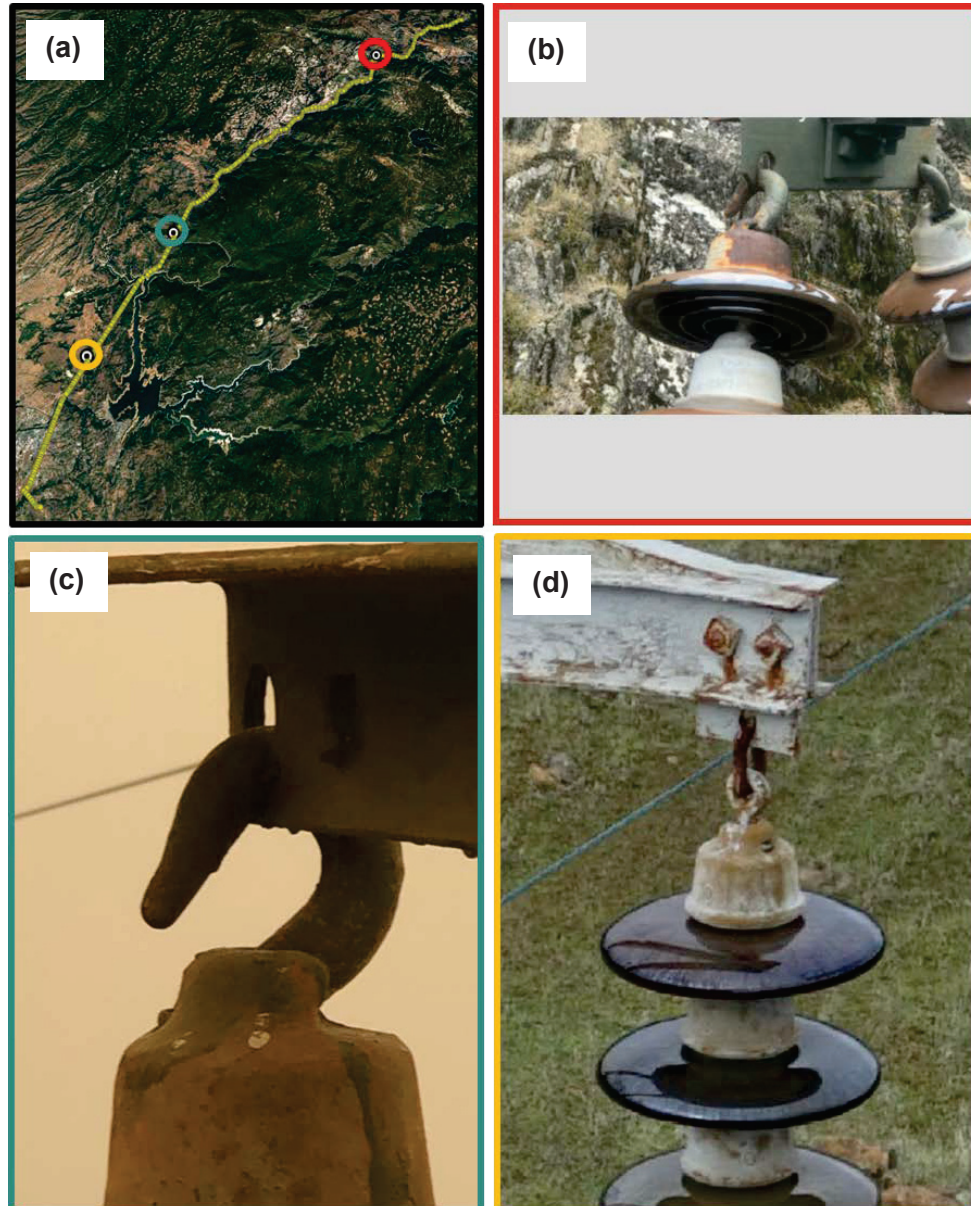
“Cold-end hardware” in this report refers both to the connector (e.g., link, c-hook, y-clevis, etc.) attached to an insulator string and to the hanger plate or shackle on the tower to which the connector attaches. Repeated relative motion between the connector and the eye of the hanger plate (or shackle) gradually wears away material from both. Photographs of cold-end hardware wear are shown in Figure 8, evidenced by the elongation of initially circular hanger-plate eyes. Over time, reduced thickness of the connector and hanger-plate from cumulative wear can result in strength reduction of both components.

Figure 8. Representative photographs of cold-end hardware wear associated with high-priority tags at the locations marked in (a), for (b) northern segment of the Caribou-Palermo line (SAP# 40910322), (c) middle of the line (SAP# 40591574), and (d) the southern region of the line (SAP# 40689950).

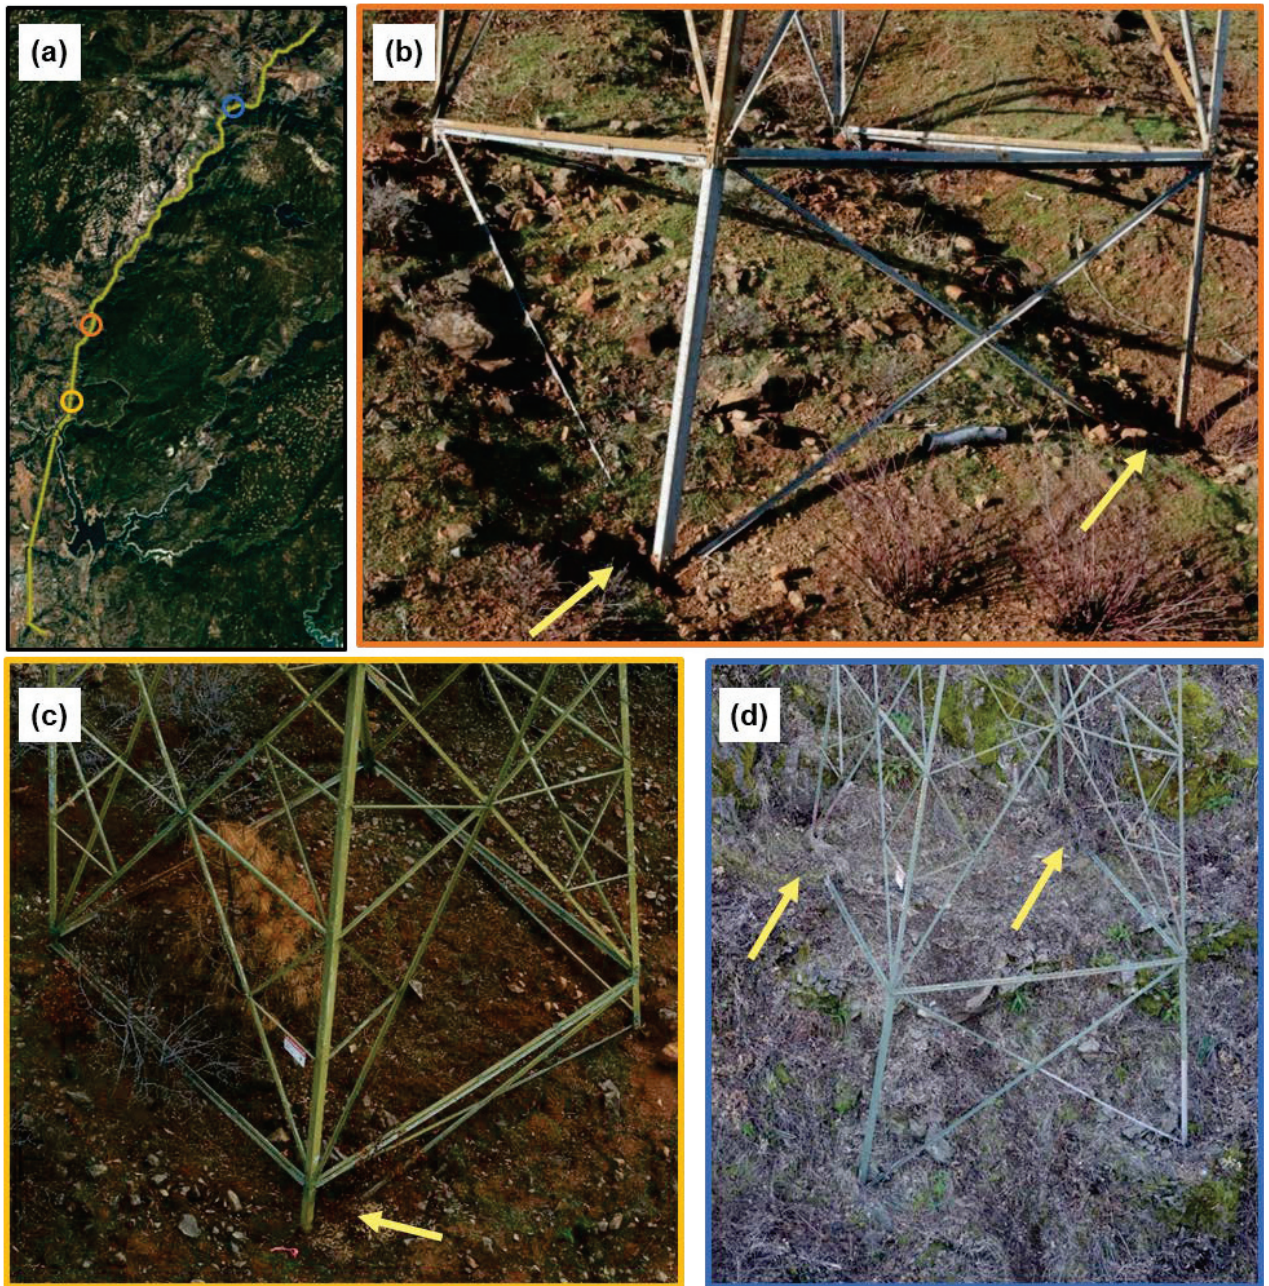
Representative photographs of soil movement around tower foundations that led to post-Camp Fire high-priority “B” tags on Caribou-Palermo are shown in Figure 9. For the three examples shown, tags were generated due to burial of the tower footings or steel lattice members. This type of soil coverage can increase the risk of corrosion of buried steel components. However, unlike wear, soil movement does not necessarily represent tower damage. Further assessment would be required to determine if soil movement associated with high-priority tags resulted in damage.

Figure 9. Representative photographs of soil movement around tower foundations associated with high-priority tags on Caribou-Palermo at the locations marked in (a), for (b) SAP# 40770937, (c) SAP# 40599306, and (d) SAP# 40910316.

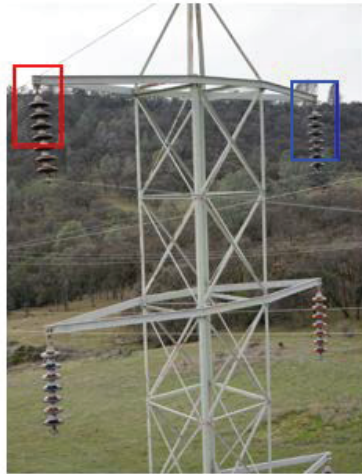
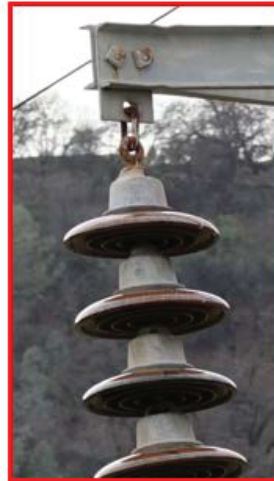
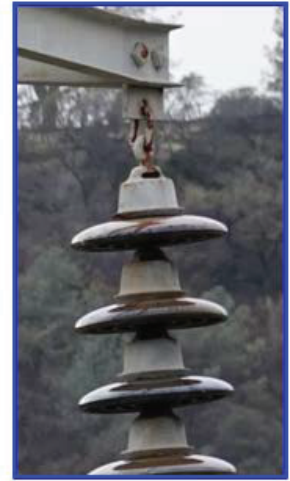
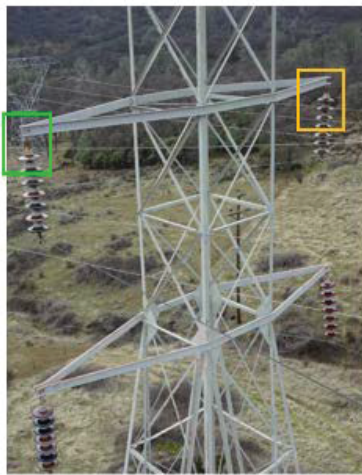
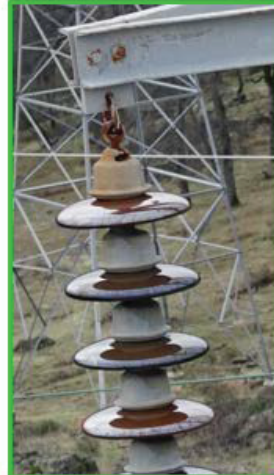
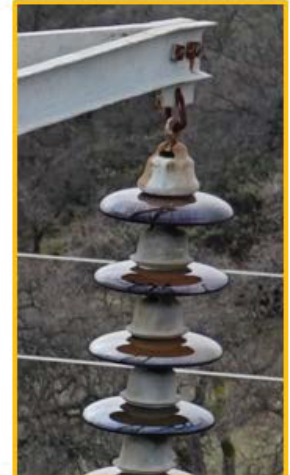
CP  
SAP: 40656339  
B Tag

Figure 18. Representative photographs of link connections found on steel lattice towers on Caribou-Palermo South.

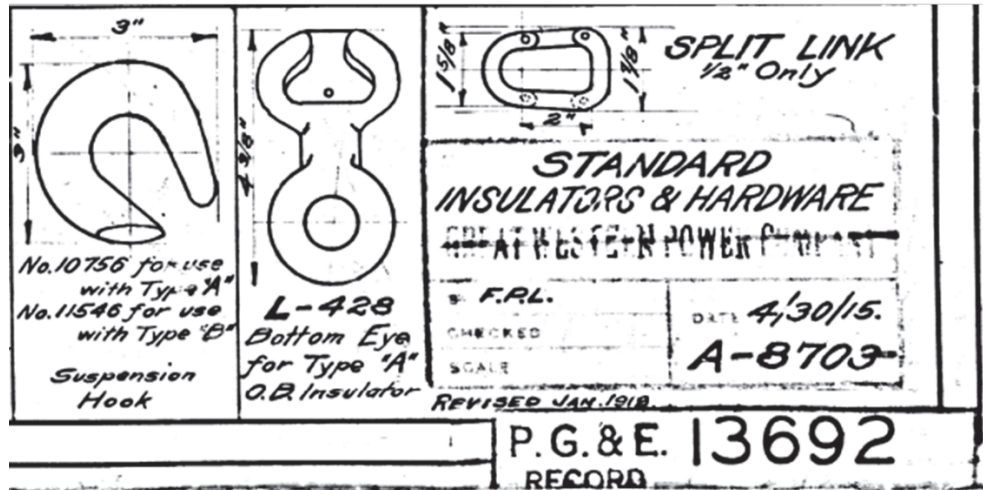
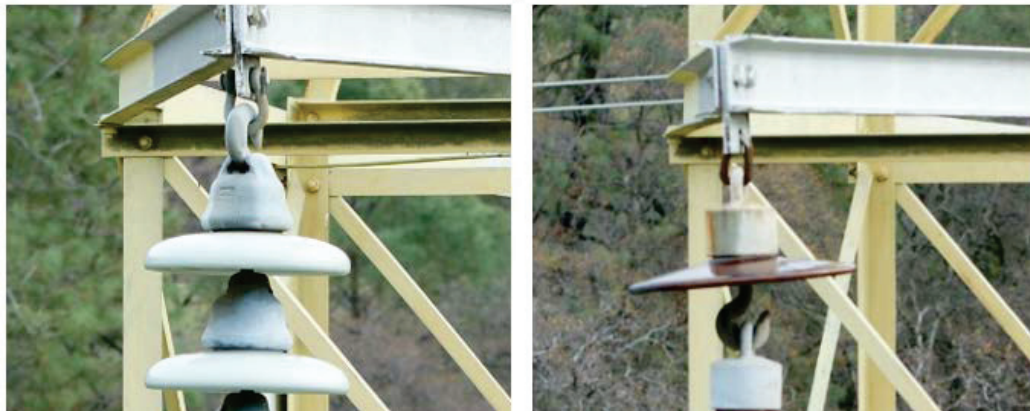
Figure 20. Design book drawing from 1918 showing C-hooks and link connections used during this time (top), and photograph of C-hooks and link connections used on Tower 007/061 on Caribou-Palermo South (bottom).

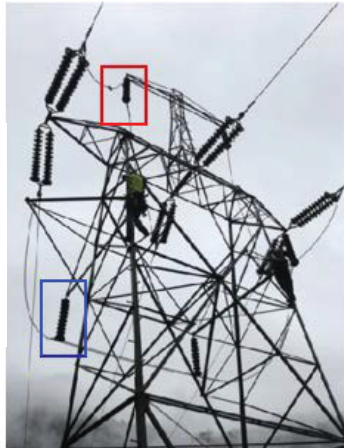
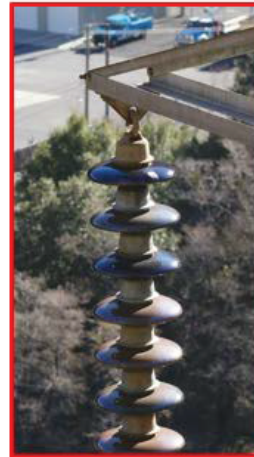
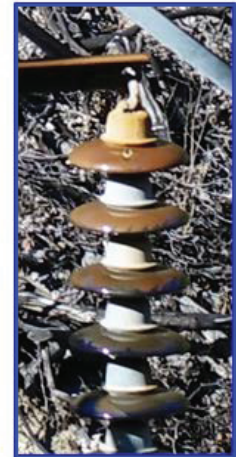
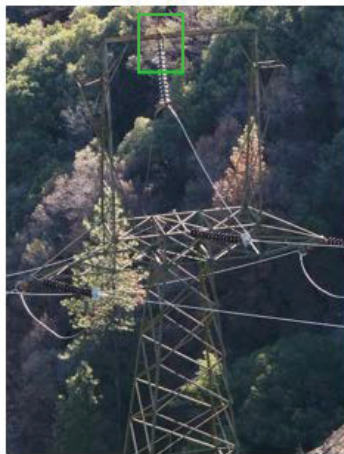
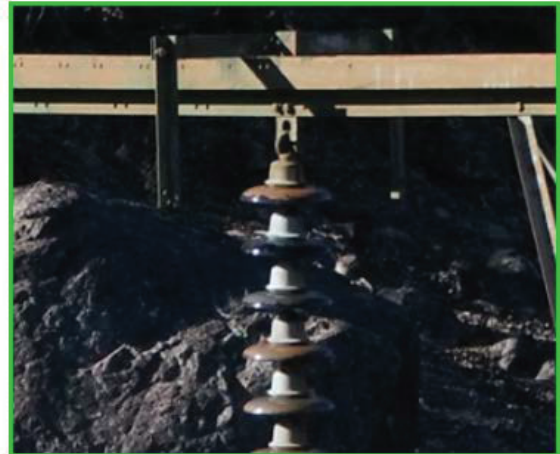
CRO  
SAP: 40911292  
B Tag

Figure 22. Representative jumper insulator cold-end hardware / wear tags within the North Fork Feather River Canyon.

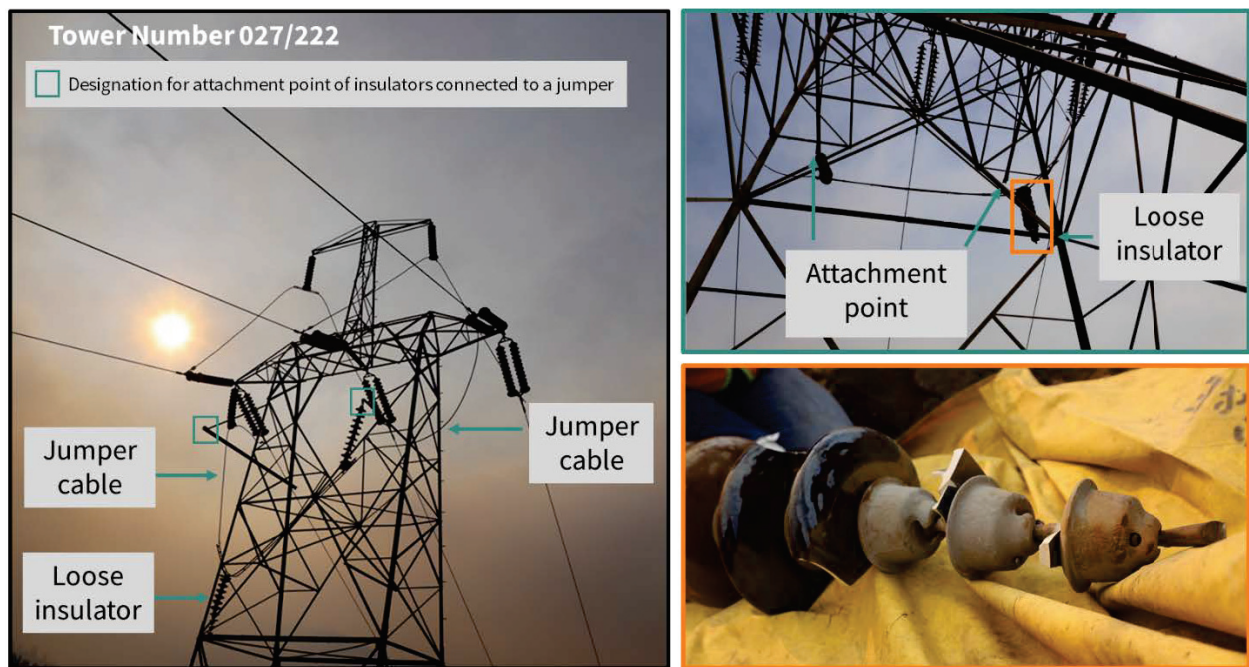
Figure 26. Images of the incident Tower :027/222 after the 2018 Camp Fire.

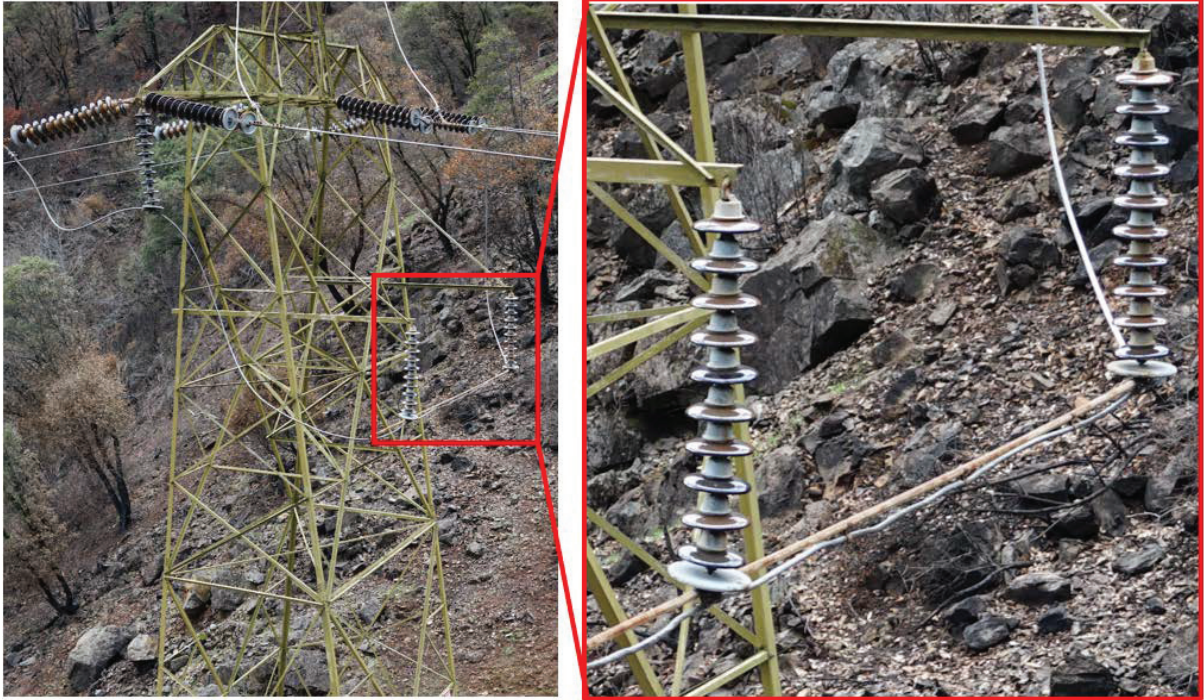
Figure 28. Photograph of transposition Tower :032/260 on Caribou-Palermo North showing the jumper suspended from insulators with an attached steel bar.
